Contract #: 04-0120F4Cty: SF/ALA Rte: 80 PM: 13.2/13.9File #: 69.28**WELDING INSPECTION REPORT****Resident Engineer:**Pursell, Gary**Address:** 333 Burma Road**City:** Oakland, CA 94607**Report No:** WIR-012923**Date Inspected:** 16-Mar-2010**Project Name:** SAS Superstructure**OSM Arrival Time:** 700**Prime Contractor:** American Bridge/Fluor Enterprises, a JV**OSM Departure Time:** 1900**Contractor:** Zhenhua Port Machinery Company, Ltd (ZPMC), Changxing Island **Location:** Shanghai,China**CWI Name:** Mr.Tu Jun/Li Lin**CWI Present:** Yes No**Inspected CWI report:** Yes No N/A**Rod Oven in Use:** Yes No N/A**Electrode to specification:** Yes No N/A**Weld Procedures Followed:** Yes No N/A**Qualified Welders:** Yes No N/A**Verified Joint Fit-up:** Yes No N/A**Approved Drawings:** Yes No N/A**Approved WPS:** Yes No N/A**Delayed / Cancelled:** Yes No N/A**Bridge No:** 34-0006**Component:** Tower**Summary of Items Observed:**

WELDING INSPECTION REPORT

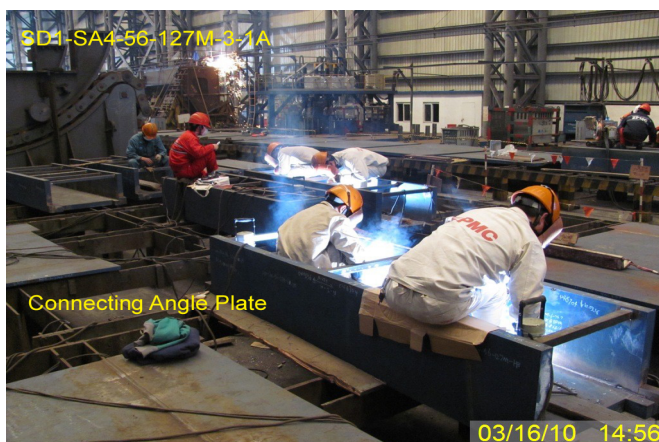
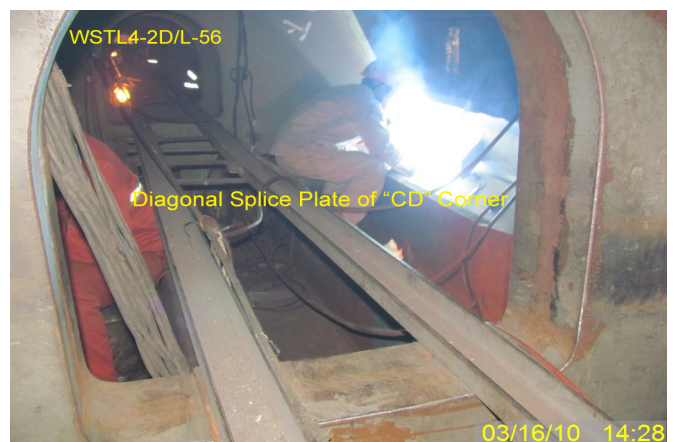
Unless otherwise noted, all work observed on this date appeared to generally comply with the applicable contract documents.
